Aquatic Connectivity Through Climate-Ready Infrastructure

Campus Subwatershed

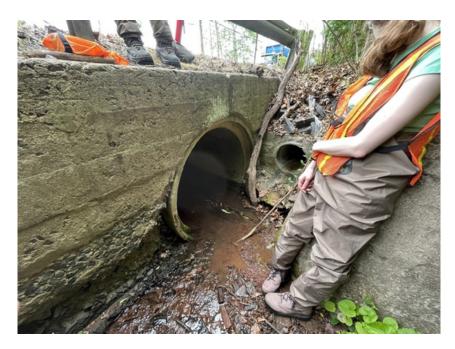
1. Highland Park E2 (@ River Rd.) is one of the small tributaries that runs underground through Johnson Park and could be daylighted to allow for more habitat connectivity for both anadromous and potadromous fish.

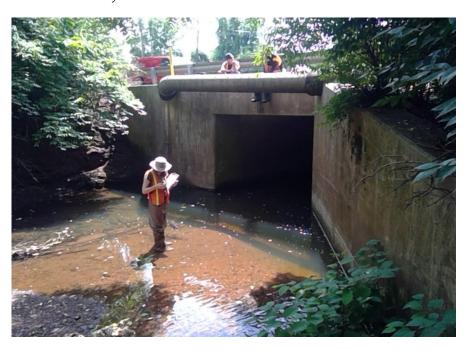
2. First Mill 1 (@ River Rd.) is a long box bridge that is severely undersized, can only accommodate a 2-year storm event, and in poor condition. This scored as a minor barrier to fish passage as well because the crossing is long and dark, which may affect the desire of anadromous fish to enter this tributary.

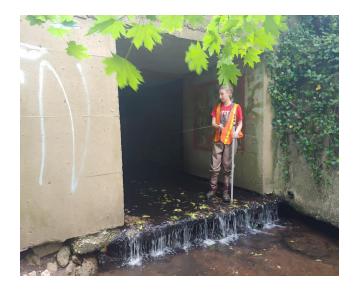
3. First Mill Tributary B2 (@ N. 5th Ave.) is a partially channelized box culvert with a concrete bottom and large outlet drop. This barrier is important for both anadromous and potadromous fish. The assessment team noticed fish at both the inlet and outlet, but they did not appear to be able to get through the structure either way.

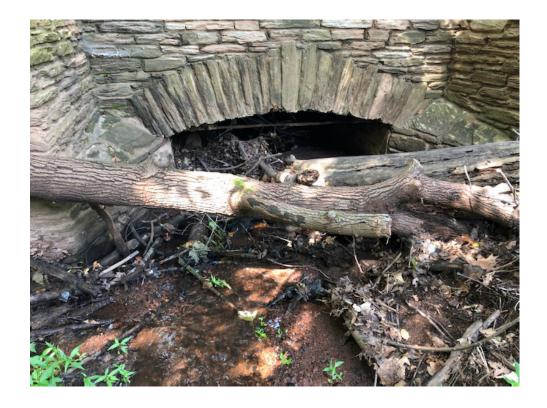
4. Buell Brook 2 (@ River Rd.) is a severely undersized culvert that can only accommodate a 2-year storm event. It is in poor condition and a barrier for anadromous fish.
